Products affected

Electric power supply for accessories to P503 suddenly disappears

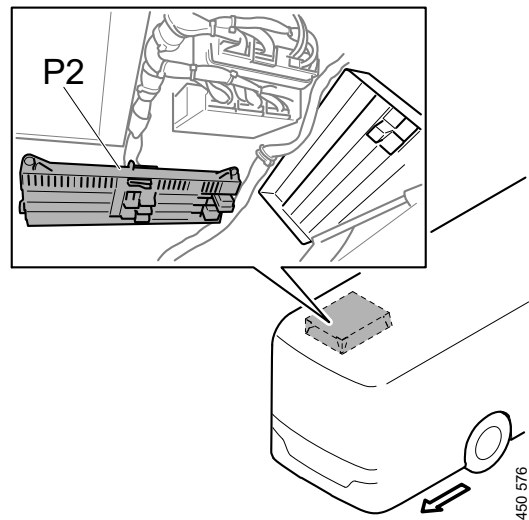
2. Locate central electric unit P2 and control unit E111 (BCI2/BCI3) and relay R115.
(usual placement according to illustration)

3. Connect the diode according to the diagram below.

Start by measuring to confirm that the diode is incorrectly oriented, use a multimeter.

If so, locate the diode between *E111/B:2* and *R115:2*.

Then cut the electrical cable a bit away from the diode on both sides, rotate it and reattach with suitable jointing sleeves.

Measure again to confirm that the diode is now correctly attached.
