## Products affected

## Fuel leakage from cover to fuel filter housing

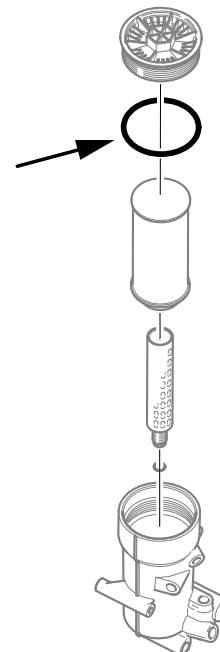
480 129

The new PDE O-ring kit must be ordered together with the filter kit. During service, the O-rings from the filter kit must be discarded and the new O-ring 3 188 368 must be used instead.

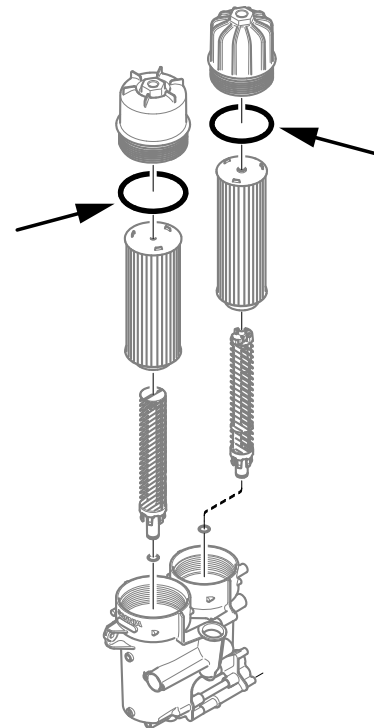
480 130

The new XPI O-ring kit should be ordered together with the filter kit. During service, the O-rings from the filter kit must be discarded and the new O-ring kit 3 191 739 must be used instead.
