A new ball bearing for the stator on the retarder

Background

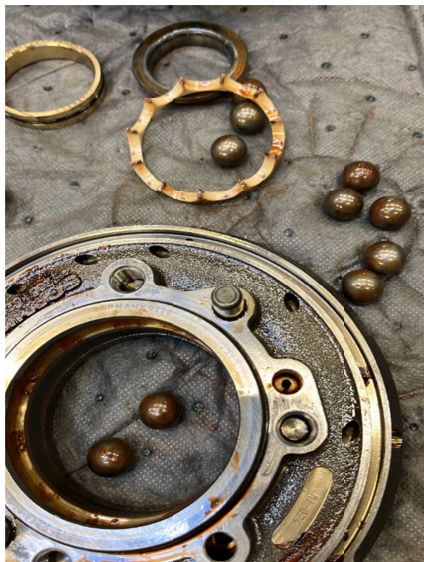
483 054

There have been cases where the ball bearing for the stator on retarder has worn out prematurely. In all these cases, the disintegration has started with the separation of the ball bearing casing.

For the retarder R4700D, a new ball bearing for stator 3093211 been introduced for the following chassis serial numbers:

For retarder R3500/4100/4100D, a new ball bearing for stator 1766998 has been introduced for the following chassis serial numbers:

For a complete description of how to replace the retarder or ball bearings, follow the instructions in the workshop manual 05-52.
