## Assembly tool 3 151 712 missing screw for working with preload of differential bearings

*Assembly tool gauge 3 151 712* – missing a screw to attach *Gauge 3 166 409*.

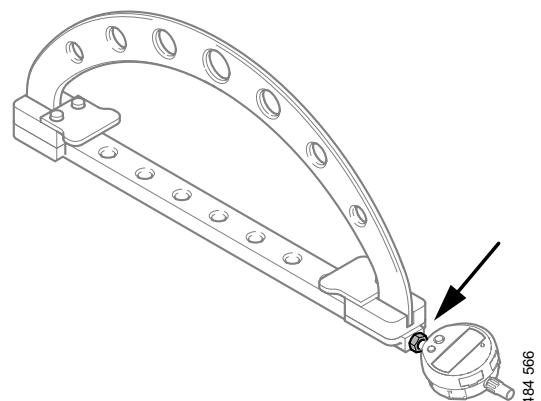
1. Place 434825-8 between 3 151 712 and 3 166 409 to attach the dial gauge.

Order the screw locally to solve the problem until *Assembly tool gauge 3 151 712* is updated with a screw inserted on the Scania number.

Supplier: Ravema AB Hoffman Group, supplier part number: 434825-8 (5 items included).
